**Flood Control Project Maintenance
Levee Inspections****LMA District Cover Sheet****Spring 2016 Levee Inspection Results****Sutter Maintenance Yard Maintenance Area 0016**

Spring 2016 Levee Inspection Results

Sutter Maintenance Yard Maintenance Area 0016

Waterway			Bank	Unit Miles
Unit No. 01 Feather River			Right	4.06
	Spring (March - May)	Summer (June - August)	(September - November) Fall	Winter (December - February)
Unit Maintenance Rating (Fall Only)				
Date of Inspection	4/5/2016 - 4/8/2016			
DWR Inspector	Sterling York			
Accompanied By	Sean Freitag

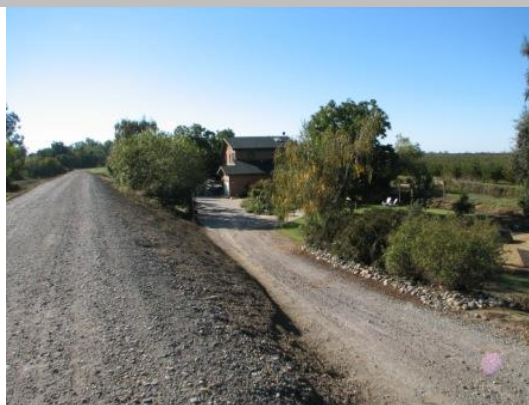
Photo 1 of 1 : SP_2016_MA0016_302_2_20160307_00001.jpg

LM Start	0.06	Rating **	M	Issue No.	2
LM End	0.10	Issue Type +	En	Location *	LS
Category	Earthen Levee			GPS Latitude/Longitude	
				Start	End
Item	Vegetation			39.256618 °	39.257228 °
				-121.636442 °	-121.636462 °
DWR ID	DWR_MA0016_01_s_2012_2				
Comment Code					
V6 : Landscaping					
Inspector Comment

This photo shows the landscaping on the landside slope and toe.

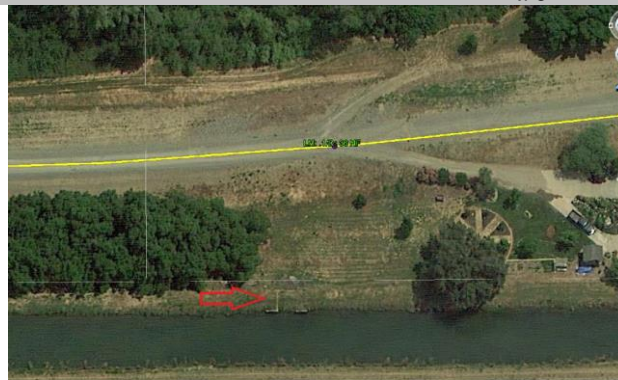
Photo 1 of 1 : UCIP_SP_2016_45934_73040.jpg

LM Start	0.11	Rating **	M	Issue No.	26
LM End	0.11	Issue Type +	En	Location *	LS
Category	Supplemental			GPS Latitude/Longitude	
				Start	End
Item	DWR UCIP Field Study			39.257308 °	39.257308 °
				-121.636582 °	-121.636582 °
DWR ID

Comment Code					
Inspector Comment					
FS_ID:45934 DS_ID:17180 EP_NO: 4556 Repair Type: Non-Urgent Crossing Status: Indicator Found UCIP Comments: 6/8/2015 Unable to locate.2/11/2015: Revised Location and added arial photo showing U-shaped concrete headwall on LS toe. Pipe should be completely removed from levee. Unable to locate any evidence of crossing 12/11/12.11/6/2013 Unable to locate.5/19/2014 SBFCA project had levee access blocked. Could not get to pipe.12/29/2014 Access bocked due to SBFCA project. FIELD_STRUCT_DESC: *ABANDONED* 36 inch CMP drainpipe through the levee 22-feet below the crown. Concrete U-shaped headwall on LS toe. Originally included in O+M manual at 473+30. Pipe was abandoned in place and a concrete plug was installed in WS slope after pipe failed in 1964 under permit No. 4556. FS Date: 6/16/2015 7:00:53 AM

Aerial photo showing location of Concrete headwall on LS toe.

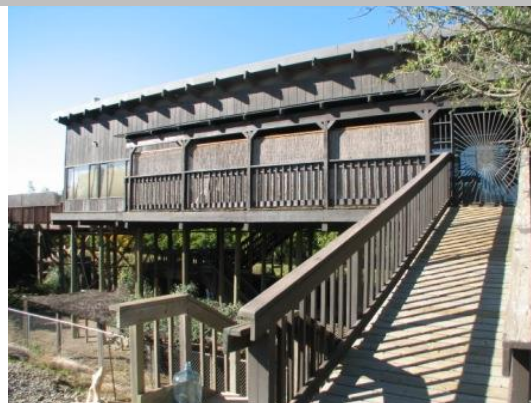
Photo 1 of 1 : SP_2016_MA0016_302_15_20160307_00004.jpg

LM Start	0.18	Rating **	M	Issue No.	15
LM End	0.18	Issue Type +	En	Location *	LS
Category	Earthen Levee			GPS Latitude/Longitude	
				Start	End
Item	Encroachments			39.258437 °	39.258437 °
				-121.636613 °	-121.636613 °
DWR ID	DWR_MA0016_01_s_2012_15				
Comment Code					
BU : Building					
Inspector Comment

Levee mile 0.18. This photo shows the building on the landside shoulder and toe.

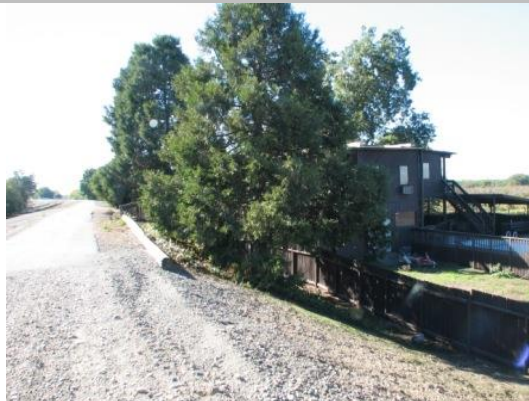
Photo 1 of 1 : SP_2016_MA0016_302_7_20160307_00002.jpg

LM Start	0.44	Rating **	U	Issue No.	7
LM End	0.49	Issue Type +	En	Location *	LS
Category	Earthen Levee			GPS Latitude/Longitude	
				Start	End
Item	Encroachments			39.262213 °	39.262825 °
				-121.636545 °	-121.636430 °
DWR ID	DWR_MA0016_01_s_2012_7				
Comment Code					
BU : Building					
Inspector Comment

Levee mile 0.49. This photo shows the building and landscaping on the landside slope and toe.

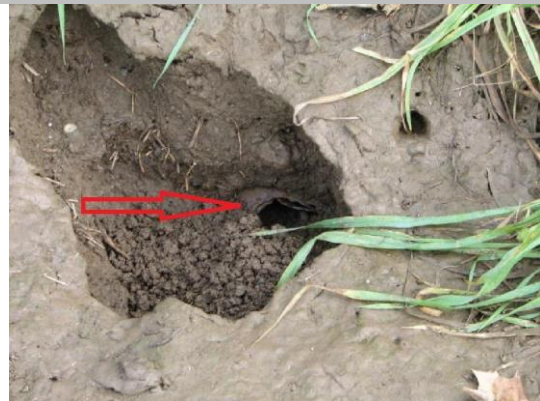
Photo 1 of 2 : UCIP_SP_2016_45938_65766.jpg

LM Start	1.69	Rating **	M	Issue No.	27
LM End	1.69	Issue Type +	En	Location *	LS
Category	Supplemental			GPS Latitude/Longitude	
				Start	End
Item	DWR UCIP Field Study			39.279812 °	39.279812 °
				-121.632987 °	-121.632987 °
DWR ID

Comment Code					
Inspector Comment					
FS_ID:45938 DS_ID:17129 EP_NO: N/A Repair Type: Non-Urgent Crossing Status: Found UCIP Comments: 6/8/2015 SBFCA project recommended replacing this pipe but after completion of the project in this area i was unable locate any signs of this crossing.Pipe is partially buried at LS toe and shows heavy corrosion. Unable to locate headwalls on either side of levee. Pipe should be cleared of soil and inspected (suspect heavy corrosion throughout pipe).5/14/2013 SBFCA project recommends replacing in accordance with title 23.5/14/2013 Same as last inspection.11/6/2013 Same as last inspection.5/19/2014 SBFCA project had levee access blocked. Could not get to pipe.12/29/2014 Access blocked due to SBFCA project. FIELD_STRUCT_DESC: 12-inch CM Storm drain pipe through the levee 14.5 feet below the crown. Slide gate on the waterward end. (O&M entry-As built available 50-4-2193A). FS Date: 6/16/2015 7:18:33 AM

Pipe at LS inlet showing heavy silt and corrosion of pipe.

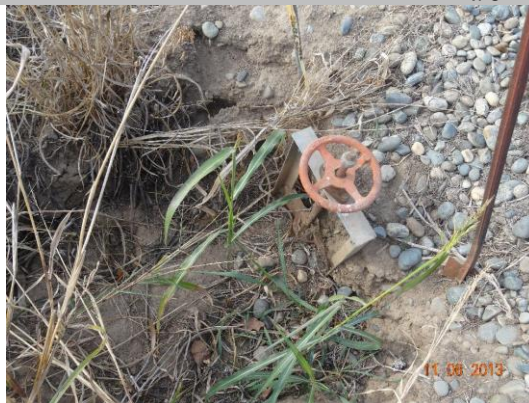
Photo 2 of 2 : UCIP_SP_2016_45938_65767.jpg

LM Start	1.69	Rating **	M	Issue No.	27 (cont)	
LM End	1.69	Issue Type +	En	Location *	LS	
Category	Supplemental			GPS Latitude/Longitude		
				Start	End	
Item	DWR UCIP Field Study			39.279812 °	39.279812 °	
				-121.632987 °	-121.632987 °	
DWR ID

Comment Code						
Inspector Comment						
FS_ID:45938 DS_ID:17129 EP_NO: N/A Repair Type: Non-Urgent Crossing Status: Found UCIP Comments: 6/8/2015 SBFCA project recommended replacing this pipe but after completion of the project in this area i was unable locate any signs of this crossing.Pipe is partially buried at LS toe and shows heavy corrosion. Unable to locate headwalls on either side of levee. Pipe should be cleared of soil and inspected (suspect heavy corrosion throughout pipe).5/14/2013 SBFCA project recommends replacing in accordance with title 23.5/14/2013 Same as last inspection.11/6/2013 Same as last inspection.5/19/2014 SBFCA project had levee access blocked. Could not get to pipe.12/29/2014 Access blocked due to SBFCA project. FIELD_STRUCT_DESC: 12-inch CM Storm drain pipe through the levee 14.5 feet below the crown. Slide gate on the waterward end. (O&M entry-As built available 50-4-2193A). FS Date: 6/16/2015 7:18:33 AM

screwgate and headwall found on LS

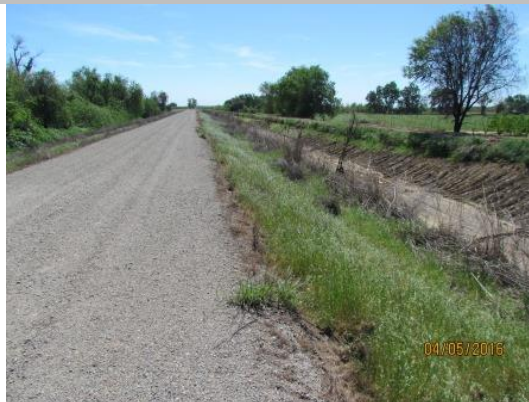
Photo 1 of 1 : SP_2016_MA0016_302_13_20160418_00014.jpg

LM Start	2.69	Rating **	M	Issue No.	13
LM End	3.08	Issue Type +	Ma	Location *	LS
Category	Earthen Levee			GPS Latitude/Longitude	
				Start	End
Item	Vegetation			39.293217 °	39.296752 °
				-121.633682 °	-121.638217 °
DWR ID	DWR_MA0016_01_s_2016_13				
Comment Code					
V1 : Control annual grass and weeds on the levee slopes and easements.					
Inspector Comment

Vegetation on landside slope looking downstream.

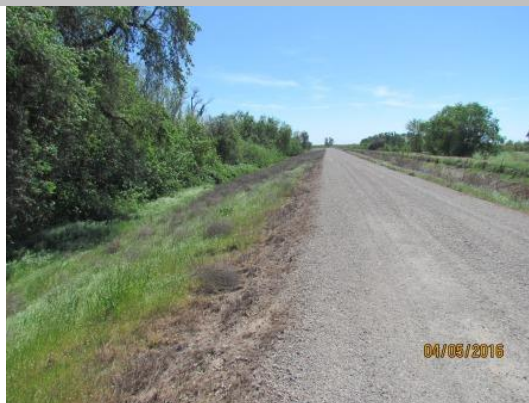
Photo 1 of 1 : SP_2016_MA0016_302_16_20160418_00013.jpg

LM Start	2.88	Rating **	M	Issue No.	16
LM End	3.08	Issue Type +	Ma	Location *	WS
Category	Earthen Levee			GPS Latitude/Longitude	
				Start	End
Item	Vegetation			39.294076 °	39.296752 °
				-121.636775 °	-121.638217 °
DWR ID	DWR_MA0016_01_s_2016_16				
Comment Code					
V1 : Control annual grass and weeds on the levee slopes and easements.					
Inspector Comment

Vegetation on waterside slope looking downstream.

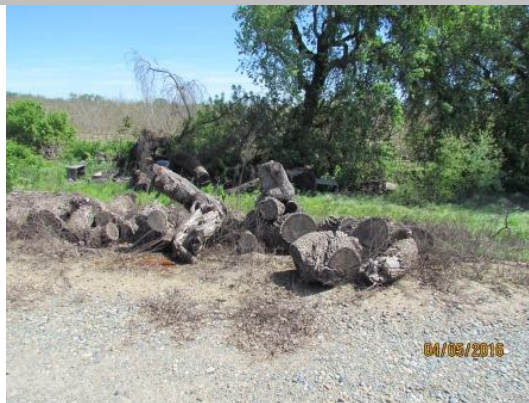
Photo 1 of 1 : SP_2016_MA0016_302_11_20160418_00015.jpg

LM Start	3.27	Rating **	M	Issue No.	11
LM End	3.27	Issue Type +	En	Location *	WS
Category	Earthen Levee			GPS Latitude/Longitude	
				Start	End
Item	Encroachments			39.299502 °	39.299502 °
				-121.638326 °	-121.638326 °
DWR ID	DWR_MA0016_01_s_2016_11				
Comment Code					
PR : Prunings					
Inspector Comment

Large pruning on waterside slope.

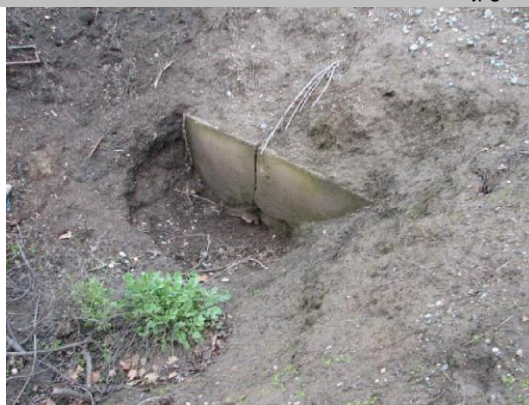
Photo 1 of 2 : UCIP_SP_2016_45943_65780.jpg

LM Start	3.39	Rating **	M	Issue No.	28
LM End	3.39	Issue Type +	En	Location *	WS
Category	Supplemental			GPS Latitude/Longitude	
				Start	End
Item	DWR UCIP Field Study			39.301218 °	39.301218 °
				-121.638332 °	-121.638332 °
DWR ID

Comment Code					
Inspector Comment					
FS_ID:45943 DS_ID:17183 EP_NO: N/A Repair Type: Non-Urgent Crossing Status: Indicator Found UCIP Comments: 6/8/2015 Concrete headwall is still cracked and inlet is buried. It was said to be replaced with the SBFCA project but the project skipped over in this area.Pipe burried on LS toe and should be inspected along with adjacent 24-inch once uncovered.5/14/2013 SBFCA project recommends replacing in accordance with title 23.5/14/2013 Same as last inspection.11/6/2013 Same as last inspection.5/19/2014 Same as last inspection.12/29/2014 Same as last inspection. FIELD_STRUCT_DESC: 2 of 2: 24-inch CMP drain pipe through the levee 16.6-feet below the crown. Headwalls at both ends and a Flap gate on the WS toe. FS Date: 6/16/2015 7:45:31 AM

Pipe should be located on either side of the one visible in this picture.

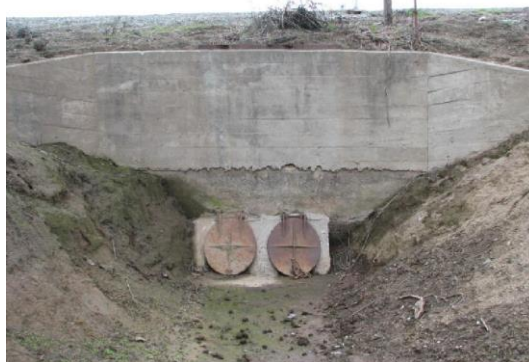
Photo 2 of 2 : UCIP_SP_2016_45943_65779.jpg

LM Start	3.39	Rating **	M	Issue No.	28 (cont)	
LM End	3.39	Issue Type +	En	Location *	WS	
Category	Supplemental			GPS Latitude/Longitude		
				Start	End	
Item	DWR UCIP Field Study			39.301218 °	39.301218 °	
				-121.638332 °	-121.638332 °	
DWR ID

Comment Code						
Inspector Comment						
FS_ID:45943						
DS_ID:17183						
EP_NO: N/A						
Repair Type: Non-Urgent						
Crossing Status: Indicator Found						
UCIP Comments: 6/8/2015 Concrete headwall is still cracked and inlet is buried. It was said to be replaced with the SBFCA project but the project skipped over in this area.Pipe burried on LS toe and should be inspected along with adjacent 24-inch once uncovered.5/14/2013 SBFCA project recommends replacing in accordance with title 23.5/14/2013 Same as last inspection.11/6/2013 Same as last inspection.5/19/2014 Same as last inspection.12/29/2014 Same as last inspection.						
FIELD_STRUCT_DESC: 2 of 2: 24-inch CMP drain pipe through the levee 16.6-feet below the crown. Headwalls at both ends and a Flap gate on the WS toe.						
FS Date: 6/16/2015 7:45:31 AM

Headwall and flap gate on WS toe.
